Case Report

Right Hip AVN with
CERAMENT™ | BONE VOID FILLER:
6 month follow-up

Cecilia Pascual-Garrido, M.D.
CU Orthopedics, University of Denver, Denver, CO, USA

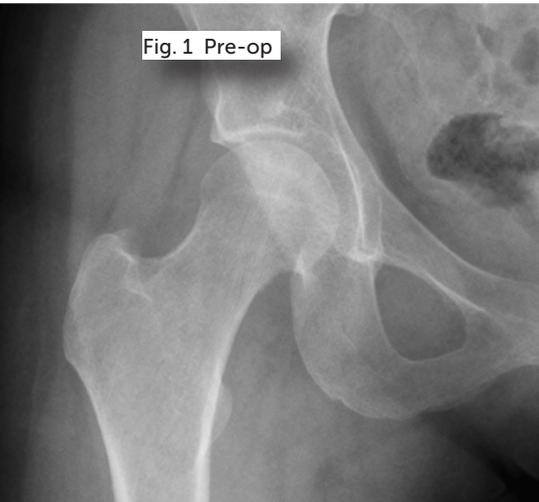
Fig. 1 Pre-op

- AVN of the right femoral head secondary to chronic steroids (Fig. 1)
- MRI showed no sign of collapse.

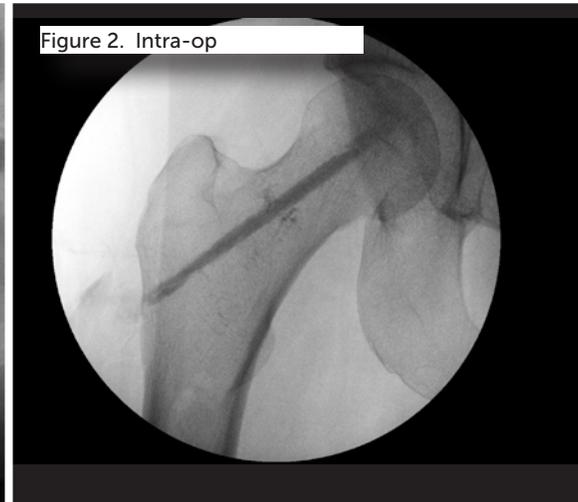
Figure 2. Intra-op

- Using C-arm imaging core decompression is performed. A K-wire was manually introduced using the same drill hole. Using the K-wire as a guide, the tip extender from the CERAMENT™ device was introduced into the hole (Fig. 2). The K-wire was then removed and the CERAMENT™ injection device was attached to the tip extender.
- Under radiographic monitoring, CERAMENT™|BONE VOID FILLER was injected from the medial to lateral and from proximal to distal, beginning in the subchordral region. The device was slowly pulled out while injecting product. Radiograph was assessed for correct filling.
- 5cc of CERAMENT™|BONE VOID FILLER was injected.

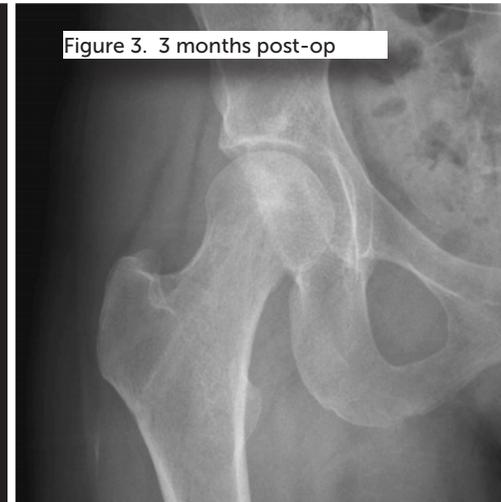
Figure 3. 3 months post-op

- Clinically the patient did very well. At 3 months post-op, the CERAMENT™|BONE VOID FILLER is no longer evident and there is complete resolution of AVN (Fig. 3).
- At 6 months post-op, the drilling area is nearly undetectable and there was no progression of disease (Fig. 4,5).
- Using CERAMENT™|BONE VOID FILLER reduced operating time to 40 minutes and allowed patient immediate weight bearing with crutches.
- Recovery and operative time were significantly improved.
